Bolting Conglomerate

We recently had the opportunity to perform some bolt tests in conglomerate, this particular type being a diamictite. This is a type of conglomerate where the pebbles are relatively unsorted (a mixture of various sizes) and with a large percentage of matrix material, the "cement" joining them together. These conglomerates are typical of those arising from glaciation as in the area we tested in the Allgau, southern Germany.

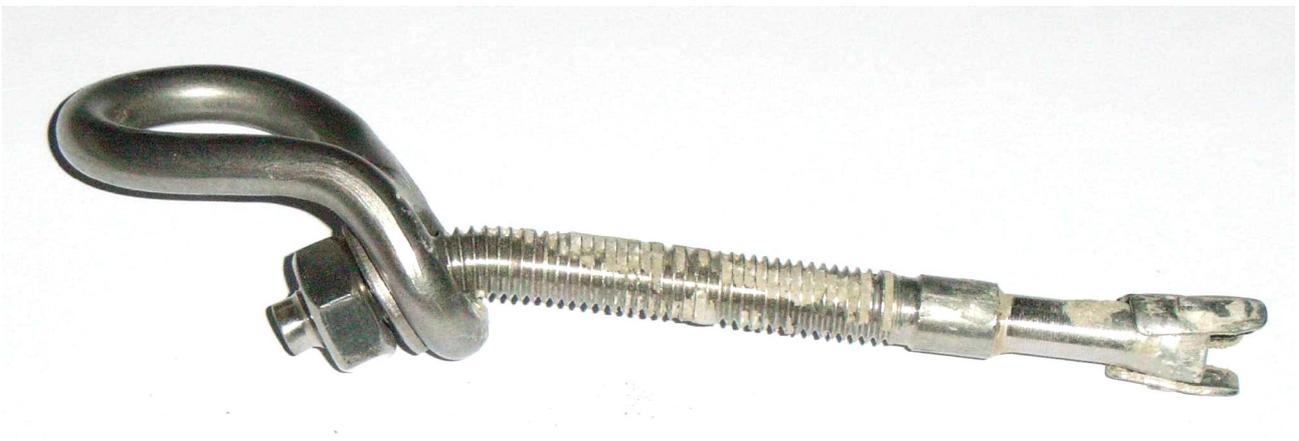
The first bolt was pulled axially and moved steadily outwards under ca 10kN load until 6cm had pulled out, it then held 26kN before completely failing as the clip pulled over the cone.

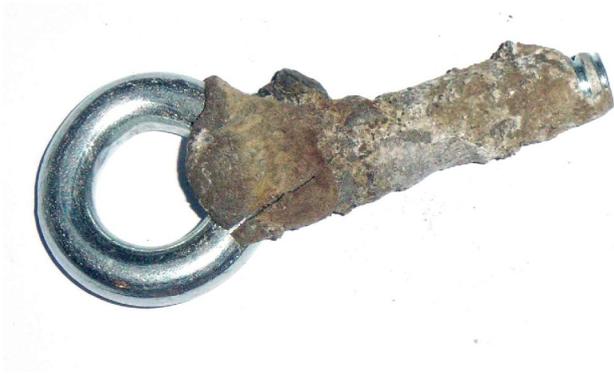
39kN on a radial pull, the rock has collapsed to about 5cm depth and now a pebble is taking the strain, luck of the draw. This bolt went on to hold 45.2kN

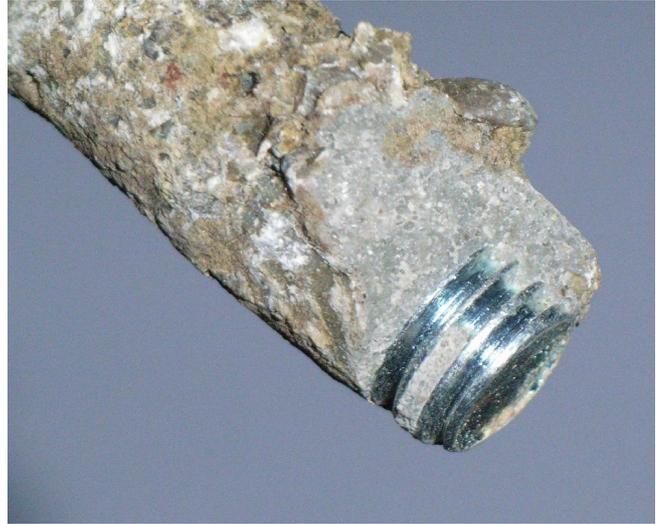
This one was not very impressive (Hilti eyebolt) in the radial tests coming out covered in sandy rubble at 11kN, as one can see drilling an accurate hole is difficult. The only bit that really held is the grey area down the bottom!

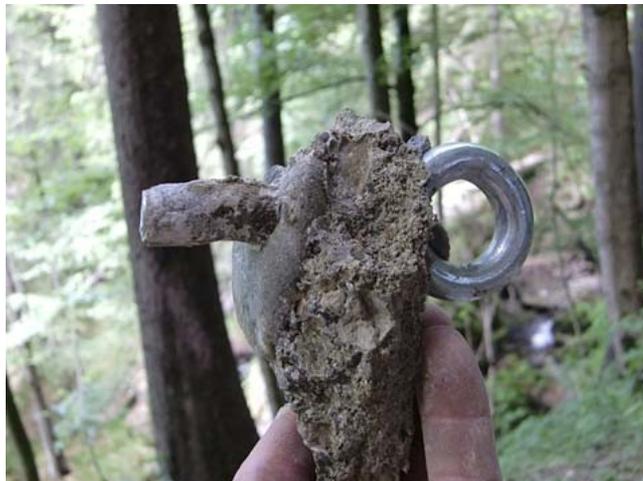
47kN on a 150mm bolt is too much for the rock, in a major way!

Clearly the answer is to stack the odds in your favour by using really long bolts, increasing the chance of getting near or into a pebble and anyway hugely increasing the amount of matrix in contact, all the 150mm bolts giving exceptional results, 100mm being more or less acceptable and everything shorter than 100mm being of extremely dubious value.

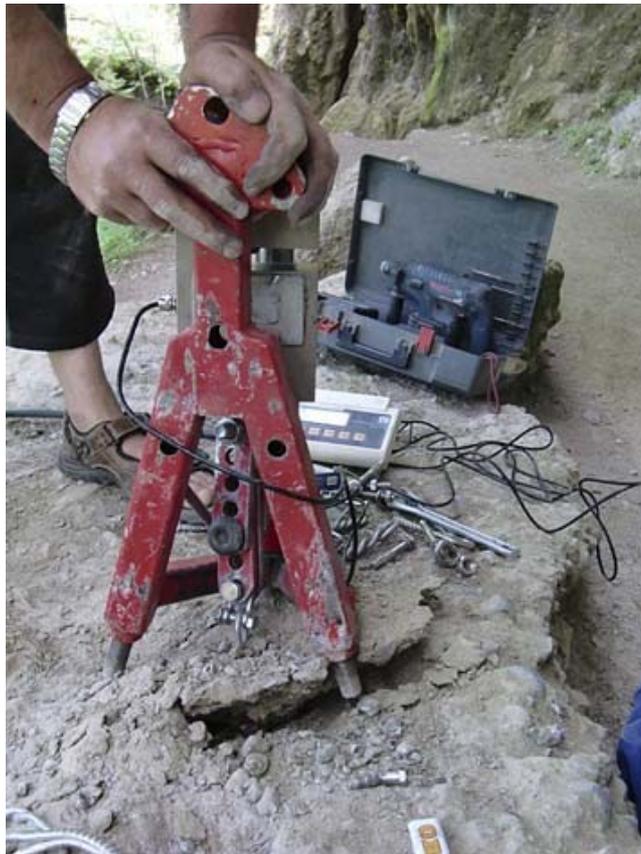
This bolt's (Hilti) reputation was helped by the pebble we drilled through!
