Bolting Conglomerate

We recently had the opportunity to perform some bolt tests in conglomerate, this particular type being a diamictite. This is a type of conglomerate where the pebbles are relatively unsorted (a mixture of various sizes) and with a large percentage of matrix material, the "cement" joining them together. These conglomerates are typical of those arising from glaciation as in the area we tested in the Allgau, southern Germany.

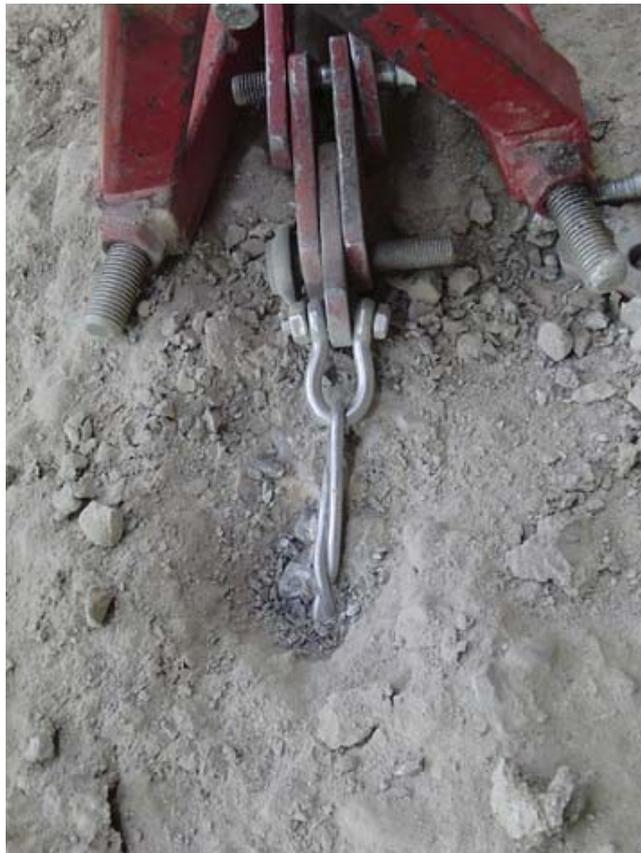
39kN on a radial pull, the rock has collapsed to about 5cm depth and now a pebble is taking the strain, luck of the draw. This bolt went on to hold 45.2kN
